Solving Moisture Mysteries with an Infrared Camera

Water leaks aren't always where you think they are

by Peter Hopkins

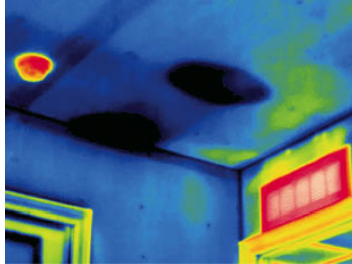
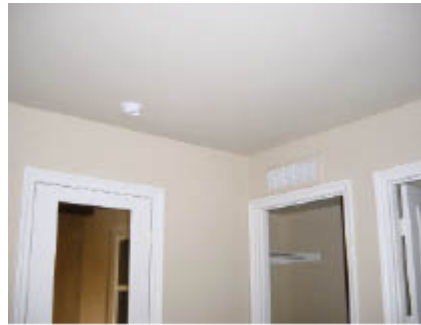
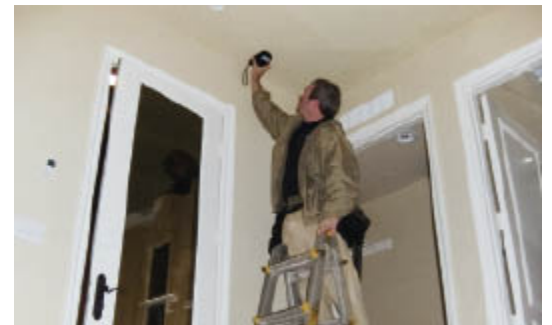
During an energy survey of a new home, the author's IR camera recorded this image (top) showing spots in the ceiling that were not visible on the drywall (bottom left), and which did not look like voids in the insulation. A hand-held moisture meter confirmed the presence of moisture (bottom right); the culprit was a leaky roof flashing.

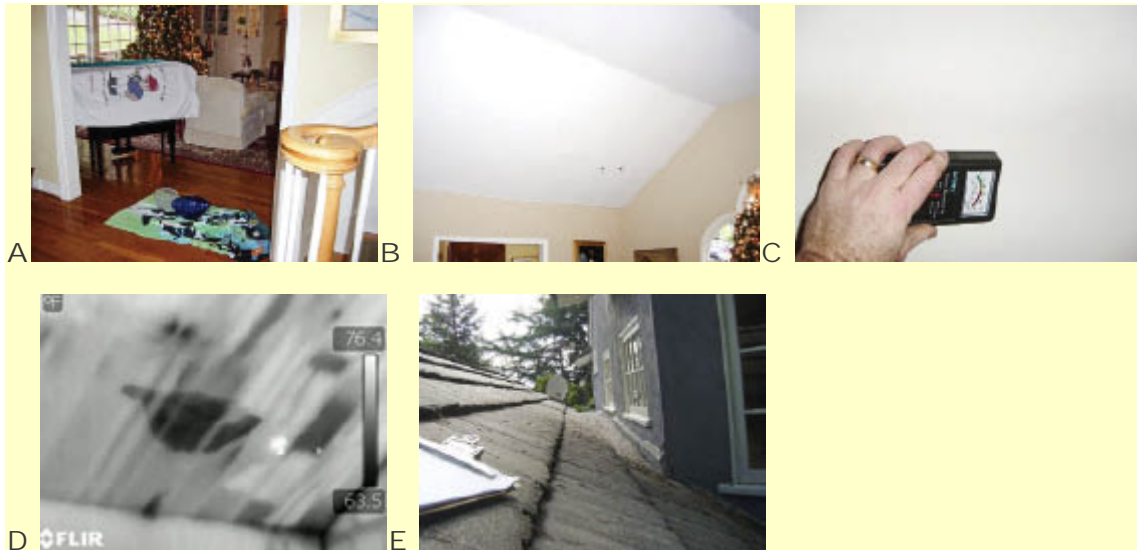
Bad Roof Design

In this case, the homeowner had already replaced the roof three times, seeking to cure an ongoing leak. The roofing contractor was now insisting that replacing an upper section of the roofing would fix the leak, but the owner wanted to try our services first. When we arrived, we found the usual assortment of buckets on the floor (A). After talking to the owner about the problem, we turned on our camera and went to work. Though you may not be able to see it in the photograph (B), there was a slight bulge in the drywall ceiling but no other signs of moisture. The moisture meter, however, read off the scale when placed on this spot (C), and an IR image (D) showed a concentration of moisture. (Note also the dark square areas to the right of the moisture spot; these indicate voids in the cathedral ceiling's insulation.)

The root of the problem turned out to be poor roof design (E). In heavy rains, water from an upper roof cascaded onto the lower steep-slope roof, where it was directed back against the building and in around the poorly executed counter flashing on the wall, eventually finding its way into the living room ceiling. Our recommendation was to install a new wide cricket flashing, taller counter flashing, and gutters on the upper roof to redirect the bulk of the water.

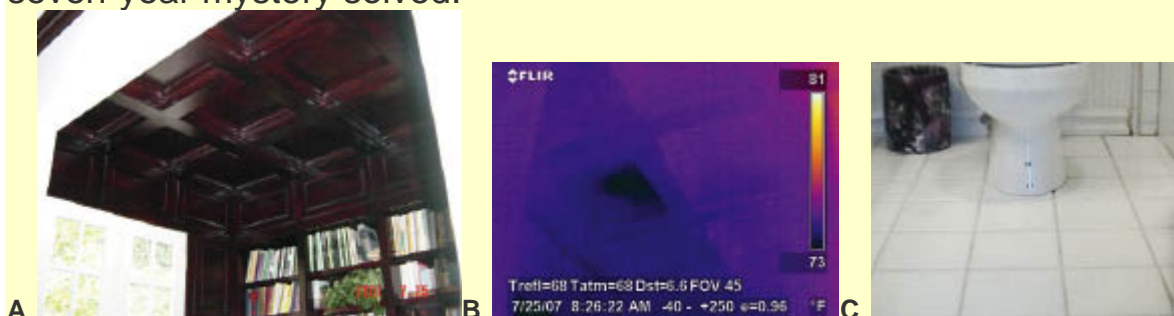
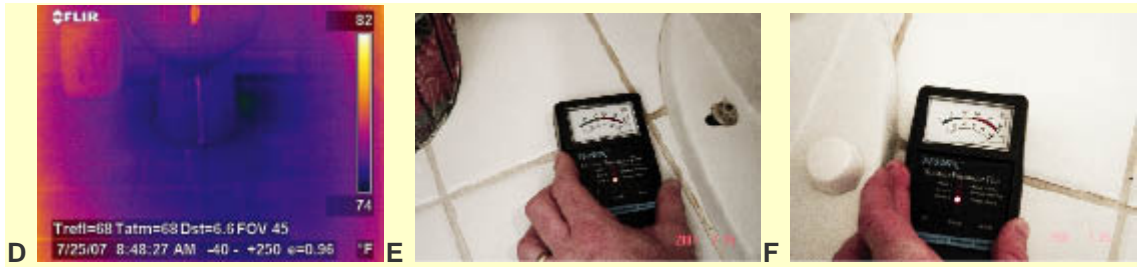
The Seven-Year Puzzle

For seven years, the homeowner had tried various repairs to fix a leak that showed up in his library ceiling (A). The bathroom above seemed the obvious source, even though it was never used. One contractor had opened up the drywall around the tub and replaced all the plumbing, but that didn't stop the leak. Another contractor replaced the angle stops on the fixtures, but — again — to no avail. The owner began to suspect the bathroom window and called me in to set up my spray apparatus and do some water testing. But first, we pulled out the camera.

The dark spot in the infrared scan of the ceiling (B) helped to pinpoint the source of the water. Upstairs, we found that this coincided with the location of the toilet (C). As you can see in the thermal image (D), there's a darker area on right side of the toilet. A moisture meter confirmed that the floor around the toilet was soaked (E, F). We made some measurements downstairs and found that the wet spot in the office was 55 inches from the outside wall — the same distance as the right-hand toilet bolt. In questioning the owner about use of the bathroom, we learned that in fact the house cleaner flushed this toilet as part of her weekly cleaning — a seven-year mystery solved.

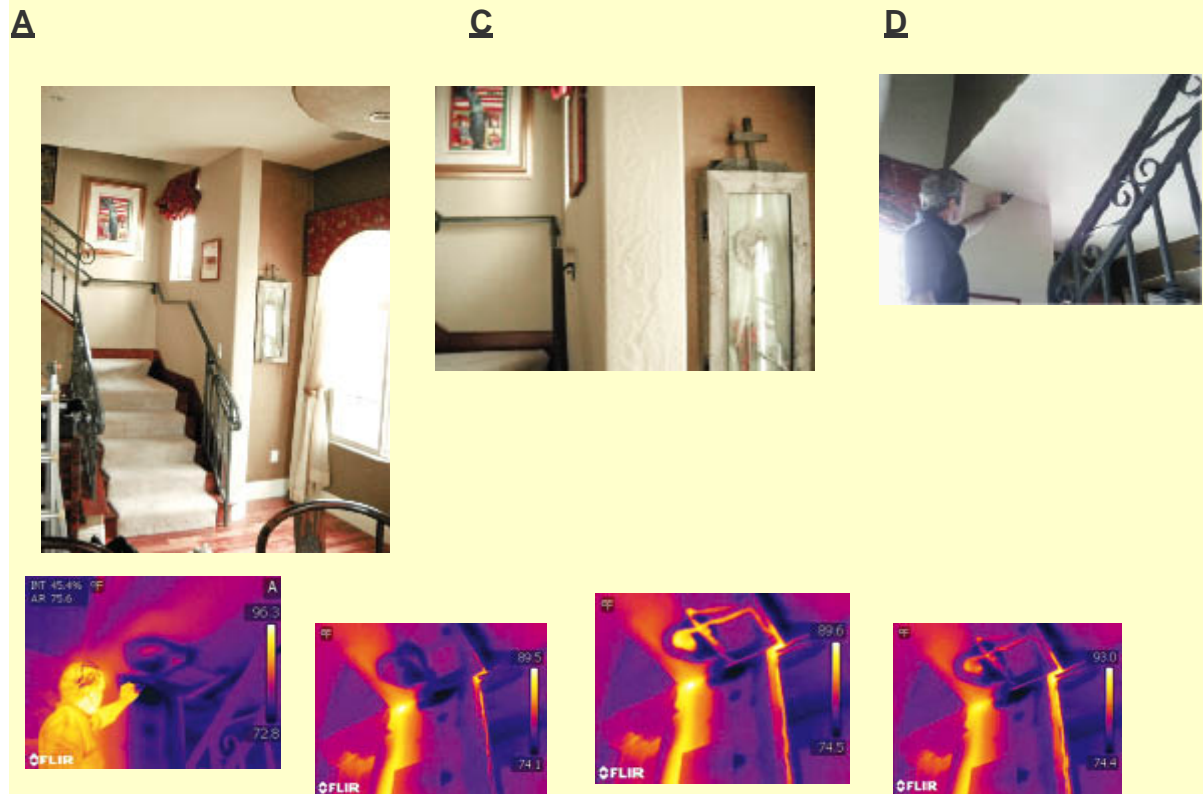
Not the Roof but the Tub

A general contractor called, saying he believed he had a roof leak in a house he had built and asking me to take a look. I found a patch of blistered paint on the return wall of the home's main staircase (A, B). Moisture readings confirmed that the wallboard in the area was damp (C). A bathroom upstairs might have been the likely culprit, but the builder had already repaired leaky supply pipes a few months earlier, so now he suspected the roof. However, the initial IR scan (D) showed a pattern of water under the bathtub, so we figured we'd start there.

We turned on the hot water and let it run, then set the camera on time-lapse mode and began scanning. In a couple of minutes, the water began to show up as a bright yellow streak coming down the corner of the wall (E). (You can also see the hot-water supply pipe running up through the wall to the left.) Then gradually, as the wall was saturated, the hot water filled in beneath the tub (F, G), which turned out to be the source of the leak.

As this case illustrates, the moisture stain is often in a different location than the leak, because water will always follow the path of least resistance. The great advantage of the infrared image is that it shows the path, right back to the source.

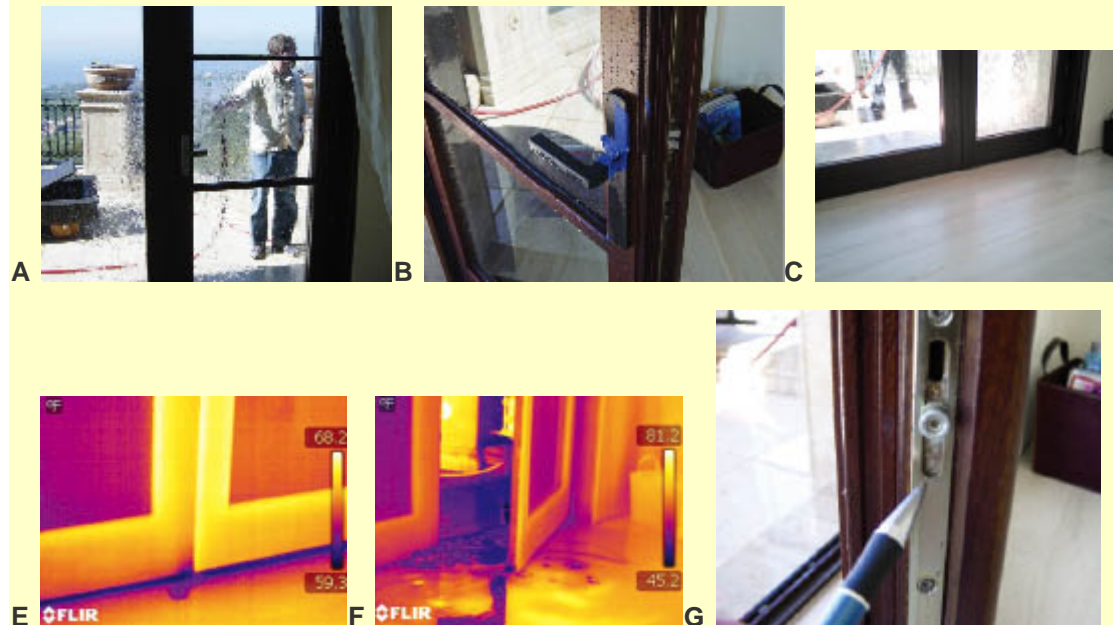
Leaky Glass Door

This home, located in Newport Coast, Calif., was eight months old when we were called in. Like many coastal homes, it had a wall of glass facing west, which bore the brunt of the storms coming off the ocean. The owner had complained that water was always coming in at the floor along the double glass doors. The builder had tried several times to fix the problem, replacing all the weather stripping and re-caulking every possible entry point, but nothing had worked. They heard about our infrared and water-testing services and called us to determine the cause.

After getting up to speed on what had been done, we used a hose to perform a water test (A), which would help us figure out where the water was getting in. We taped off obvious points of entry, like the keyhole (B), to rule those out. Before long, water was coming in under the door, as both the visual and infrared photos show (C, D). When we opened the door, the IR scanner quickly picked up something that might not have been obvious — the water was flowing out from inside the bottom corner of the door (E). The problem wasn't the caulking or weather stripping, but simply a small gap between the door handle and the faceplate, which allowed water to enter and run down through the three-point locking mechanism. Note the rust spot on the hardware (F) where the water came in. We recommended adding a rubber washer between the handle and the plate — an inexpensive fix, considering how much money had been invested in trying to solve the problem.

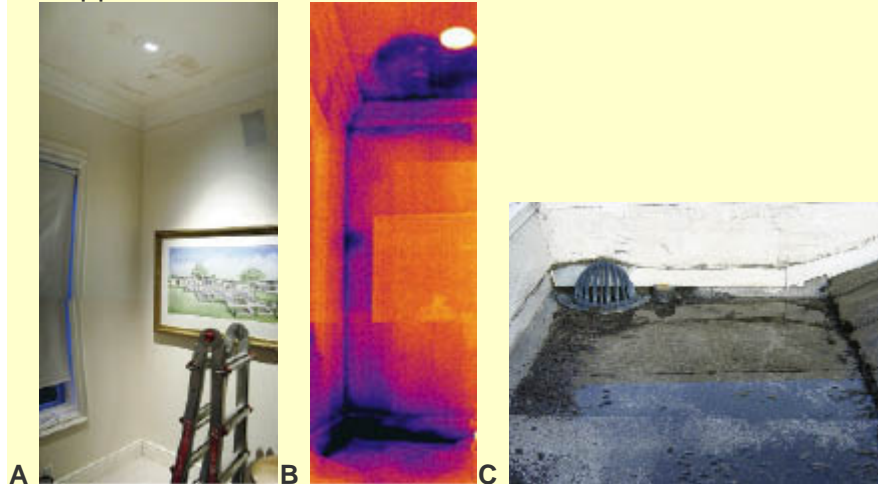
Flat Roof Leak

As you can see from the visual image (A), there was some moisture damage on the ceiling, but it seemed to be limited to that one location. But in the thermal image (B), it's obvious from the darker areas that the water had in fact traveled all the way to the floor. When we went up on the roof, we found that **pond~ing** was occurring because an overflow drain at the parapet wall was improperly installed (C). This was a leak waiting to happen.

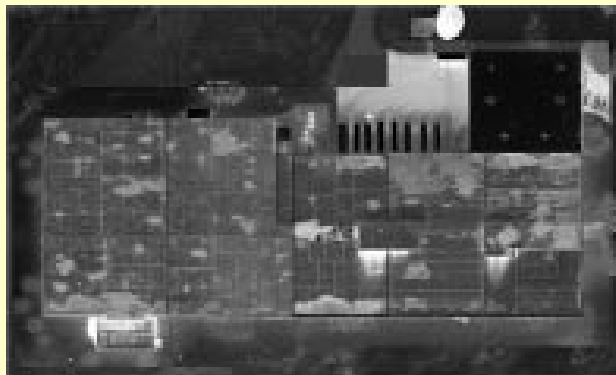
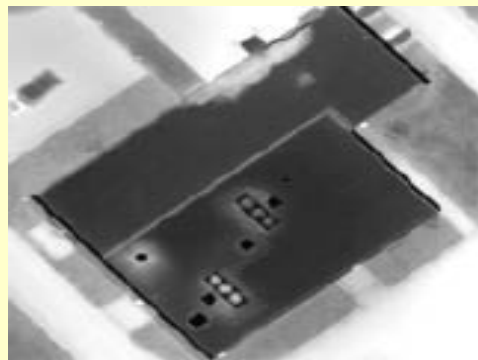
The white lines in this scan of a large low-slope roof (A) indicate moisture trapped along the edges of the rigid insulation panels. The other light-colored irregularly shaped areas show places where the insulation is wet. In the image of a flat roof (B), the light-colored area at the top indicates moisture in the roof substrate.
